The connector from fuel tank to fuel pump sheared off

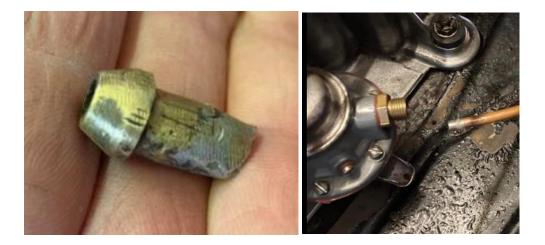
looks like it was soldered on before.

Originally these nipples, were silver soldered on, conventional soft solder is not strong enough. I have for the past 65 years repaired numerous Austin 7 petrol pipes, Austin never used soft or tinmans solder for fixing nipples to copper pipes, the reason for using Silver Solder is the high tensile strength of the solder, which makes it very resistant to vibration.

Vibration is a problem that was always present with A7 engines, particularly early models prior to the introduction of crankcase flexible mountings.

One extra benefit of silver solder, is that the silver content makes it resistant to the Ethanol content in modern petrol, whereas soft solder can be attacked by the Ethanol content.

I still repair A7 petrol pipes by use of silver solder, the silver rods are easily obtained via the Internet, but you do need to use Map gas (yellow container) in your blow torch, also it's important to remove all of the soft solder which may be present.
