## A7 Crankcase Refurbishment

### Garrett

Bob

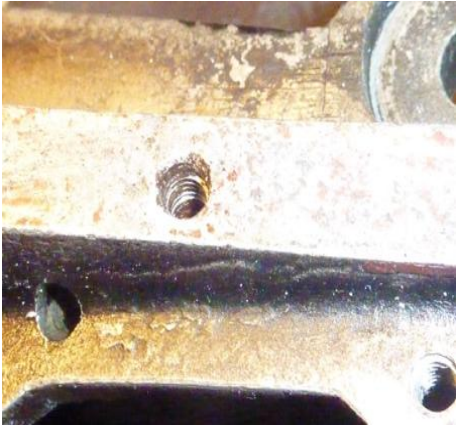
*Typical of many sunken 'Helicoils'*

Clearly, it would be impossible to achieve an oiltight and secure sump to crankcase joint unless these problems could be resolved. So, after removing the strange oversized stud and all the Helicoils (by drilling and using a left-hand taper extractor), all fourteen sump threads were drilled 3/8" Dia x 32 tpi tapping i.e. 11/32" Dia (78% engagement). Each hole was then carefully threaded 3/8" x 32 exactly at right-angles to the joint face using a simple two inch Dia mild steel 'button' held firmly by hand against the alloy face.

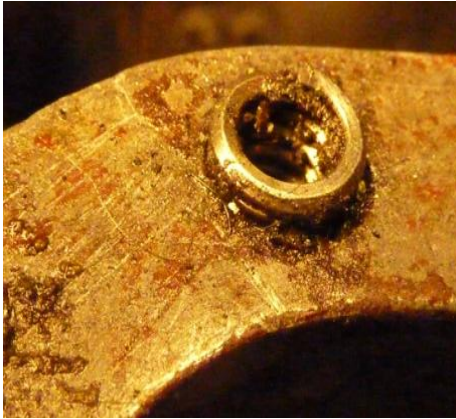
*One or two raised 'Helicoils'*

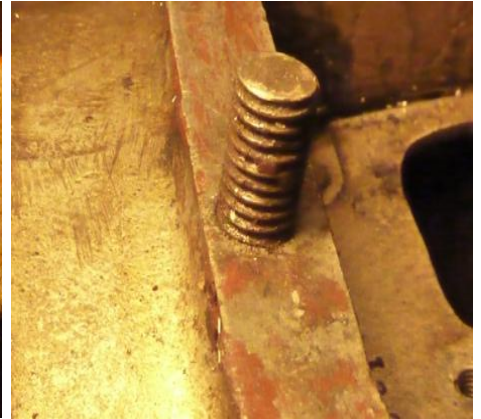
*One oversize stud*

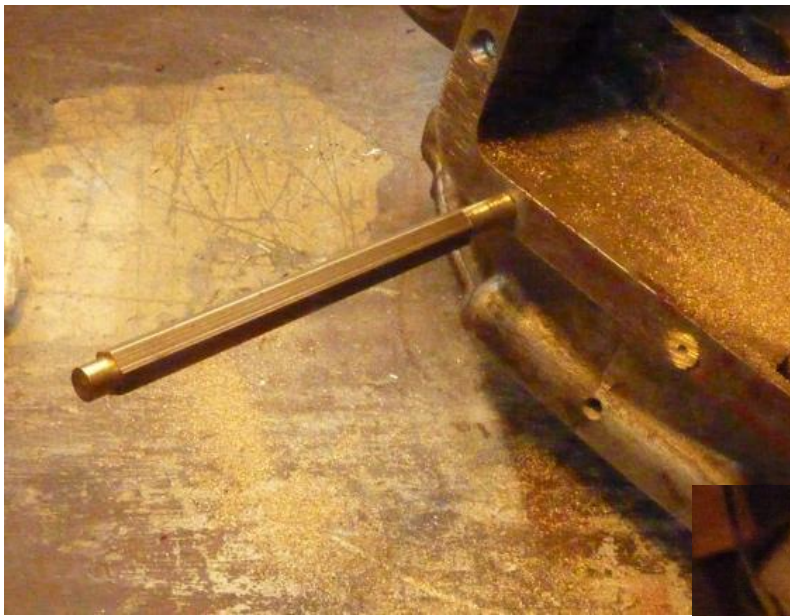
*Installing a brass bush prior to cutting-off flush*

Each brass insert was then sawn-off close to the base of the crankcase. The protruding inserts were initially trimmed using a suitably sized pin drill with a 3/16" Dia pilot then the whole sump face filed flat and finished flush by lapping with grinding paste & diesel on a lovely flat offcut of granite kitchen work surface.

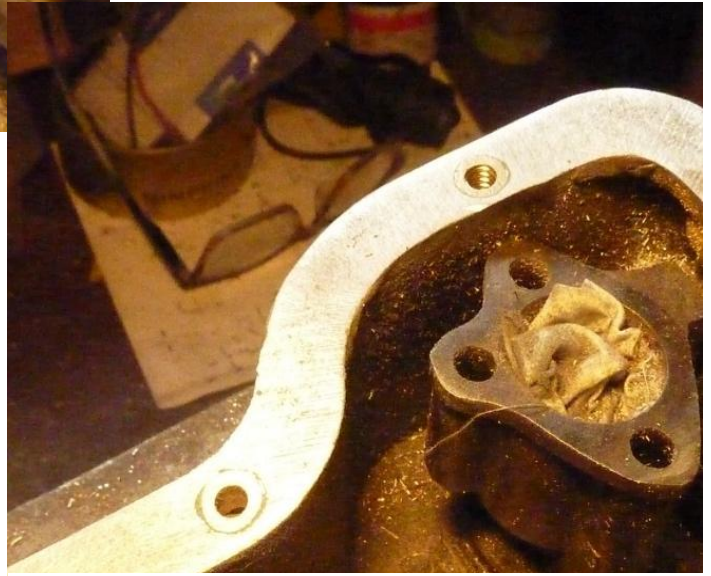
*Brass inserts complete and threaded 1/4" BSW*

Finally, the pilot holes were opened-out to 1/4" Whitworth tapping i.e. 5.1. mm Dia (76% engagement) and threaded 1/4" BSW to correspond with Sir Herbert's original design.

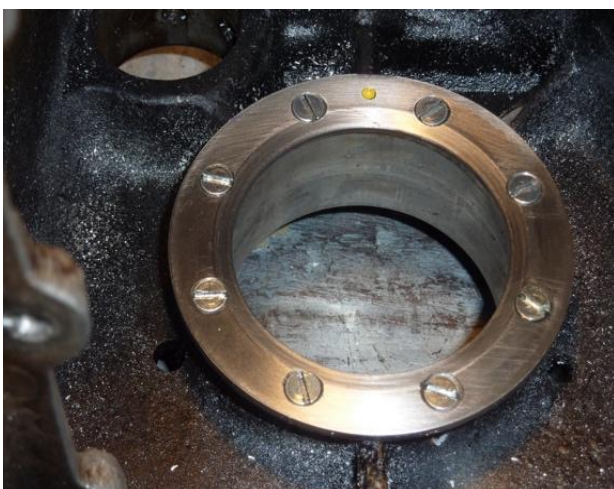
*New steel front lip*

The remains of the front main bearing flange were machined away and a new steel flange set-screwed in position all as previously described in Section 1 of the A7 engine building article Part 1 pages 4, 5 & 6 previously published during 2018-19 in our Newsletter *Crankhandle* and available in the Technical section of the Club's Website.
