Refurbishment of Austin Seven – Semi-Girling brakes

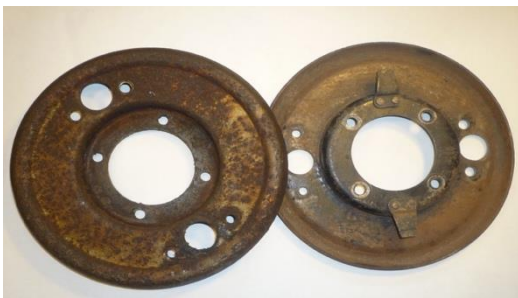
Original backplates

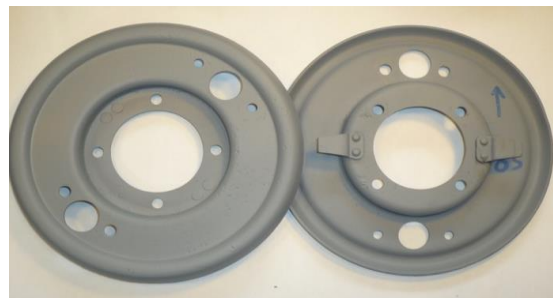
Backplates cleaned and etch primed

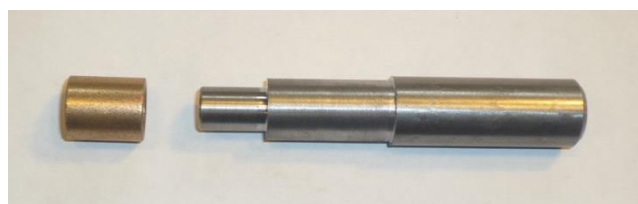
New 'Oilite' bush and bespoke drift

'oilite' bushes replaced, by drifting out the old ones and replacing them with new, using a simply turned-up mild steel drift. Before fitting, the 'Oilite' bushes were soaked overnight in oil. The lead end of the drift was made an easy fit in the new bushes and the following shoulder just a few thou' smaller than their OD. The bushes

seemed to be a fairly light press fit in the housings (presumably to preserve an accurate ID after fitting) so, a thin smear of Loctite 242 was employed on the outer surface to hold the bushes securely in position, whilst taking care to keep any Loctite clear of the bore.

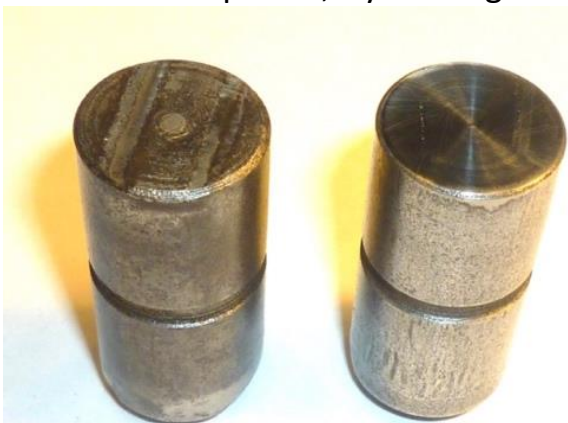
Ground actuator on right

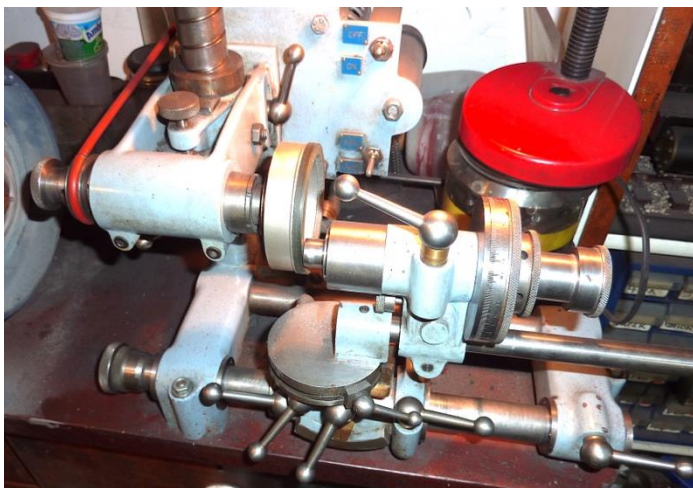
Refacing actuator plungers

The actuator plungers were found to be an excellent sliding fit in the alloy housings but their inner hardened end faces were marked where the operating paddles had worn significant grooves over the past 80+ years of use. These marks were quickly removed using a 5/8" collet to hold them in a Model Engineer's universal grinder.

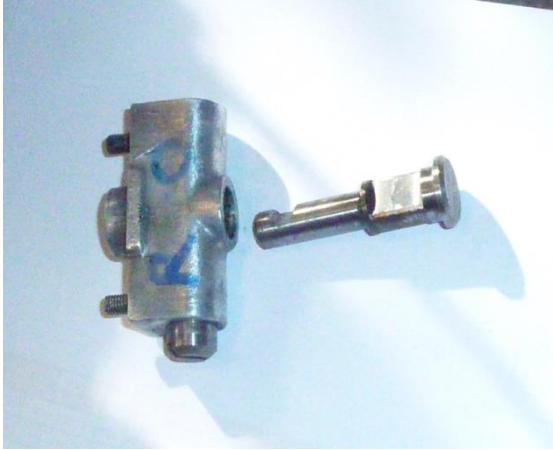
Actuator ready for assembly

The actuators were assembled on the backplates with new coil return springs, greased felt seals, and correct castle nuts etc. The Adjusters were also dismantled and cleaned and found to be in good working condition then lubricated and attached to the backplates using the original setscrews with new locking washers.

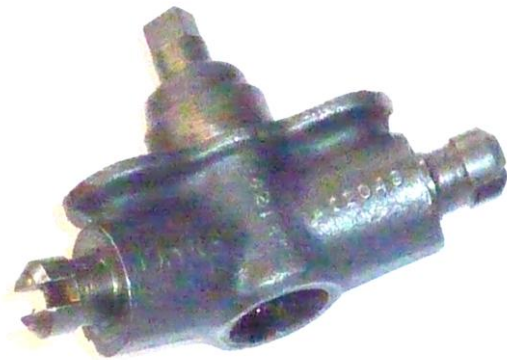
Adjuster ready for assembly

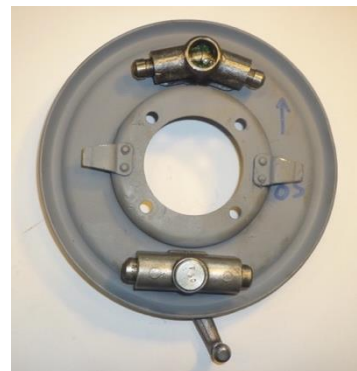
Actuator & adjuster in position

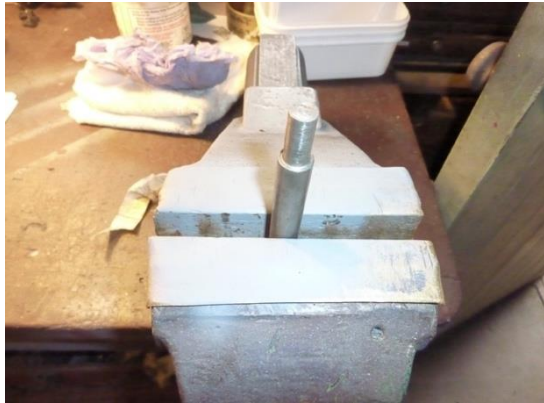
0.365" Dia Mandrel

The linings were attached to the shoes with the provided 3/16" dia' semi-hollow copper rivets working from the centre of each shoe. With a 0.365" dia simple flat-faced mild steel mandrel held vertically in the vice, the rivets were first opened slightly with a narrow lathe dead-centre, then rounded-over with a special drift that I turned-up many years ago. The rivets were then finished-off, using the ball-pein end of a small hammer taking care to ensure firm attachment without damaging the linings.

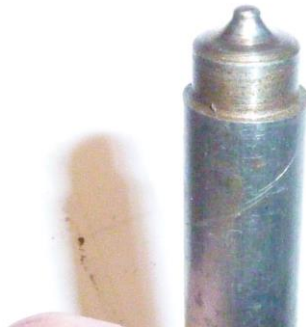
Hollow rivet drift

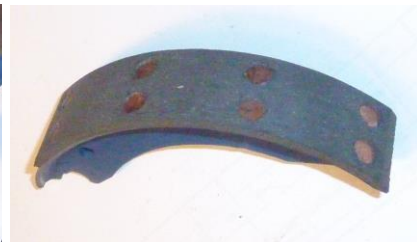
All rivets in position
