Technical tips

TAPPET COVER SANDWICH

Modification to stop oil leaks round the rocker cover

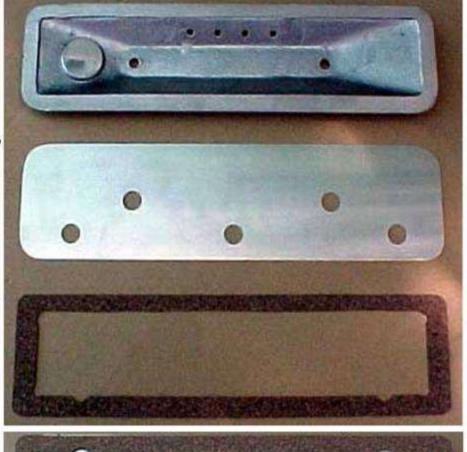
large area neoprene/cork material supplied from clubs tends to distort badly

neoprene/cork material supplied from clubs tends to distort badly and could cause long term problems. This can be overcome by using a thin aluminium sheet as a baffle and a thinner neoprene/cork seal to provide the seal. Loctite 515 was used to seal the aluminium cover to the aluminium baffle.

The original pressed steel tappet cover provided a possible source for oil leaks. Many Austin Seven owner have converted to a cast aluminium cover available from most clubs and Austin Seven specialists. Users of this modification should pay special attention to the type of flat gasket that is used with the new cover design. I have found that the current large area
