Dynamator 1

Ron Sadler and myself, recently installed Dynamators on our cars. After approximately 200 miles, both of us have suffered camshaft gear failures. There have been others outside of HA7C who have also suffered this huge inconvenience. The problem is likely to be due to the manufacture of the Dynamator gear which meshes with the camshaft timing gear.

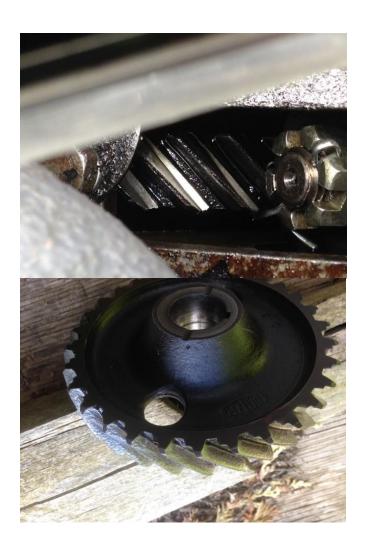
And these two are of Ron's timing gear.

Those who have already installed the Dynamator would be wise to check through the timing cover inspection hatch to see what the condition of the teeth are like, on the camshaft timing gear. Those who are about to install, would be wise to remove the supplied Dynamator gear and replace it with an Austin dynamo gear.

For the moment we are now suppling the dynamotor without the gear on the front and instructing customers to use their original gear. We will be looking into the viability of producing a full set of new gears (that we have now procured) at a later date but cost may be prohibitive. If no original gear is available we will supply the new gear but with a warning that this should be checked for wear at regular intervals .
