Fan belt Pulleys Frank Sibly & Eddie Loader

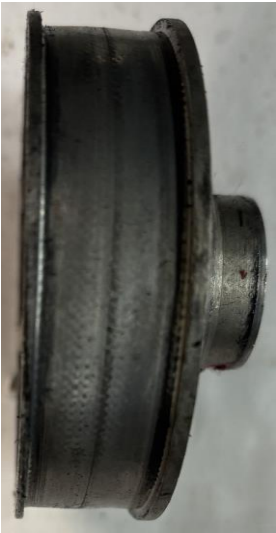
Left: Bottom fanbelt pulley, with its front to the left. The front lip is very worn and narrow, and the groove is flat instead of being crowned. The original shape of the pulley groove was convex, as this is a drum-style pulley. A flat belt climbs up to the top of the crown, and this design helps keep it centred (I can't explain why this happens!). From 1936 A7 pulleys were made from steel, as by then it had been found that the aluminium ones wore too quickly

Austin Reproduction parts austinrepro.com can supply a new starting dog, and both pulleys, for £137.

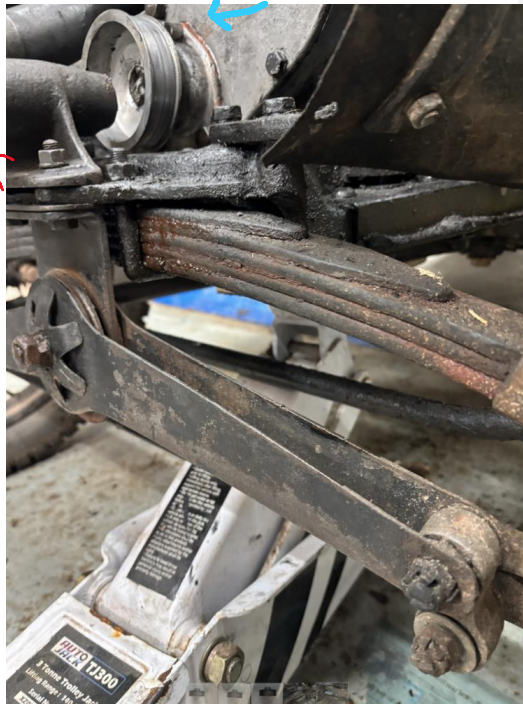
Engine jacked up from chassis, so that lower fanbelt pulley (blue arrow) can be pulled off forwards, clearing the front of the chassis (red arrow).

To get the bottom pulley off requires jacking the engine up to clear

the front chassis member.
