Frank's Chummy suddenly developed very rough running of the engine. It was irregularly missing a beat every half a second or so. It had done it before, but was seemingly cured by changing the spark plugs, but not this time. I used the great benefit of the HA7C, and rang for help from the Tech Advisor. This is the steps I took:

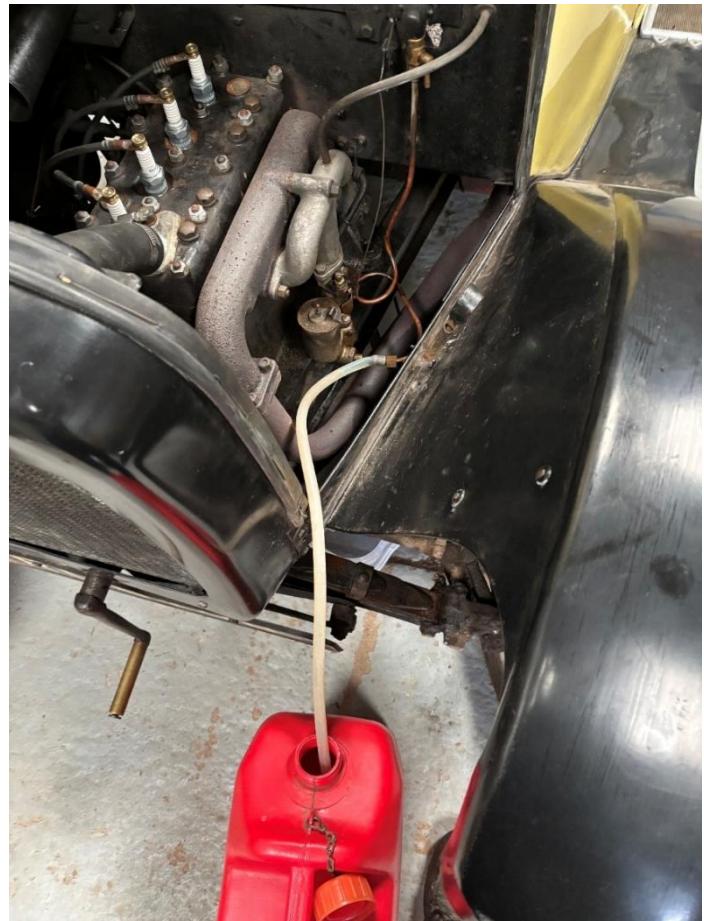
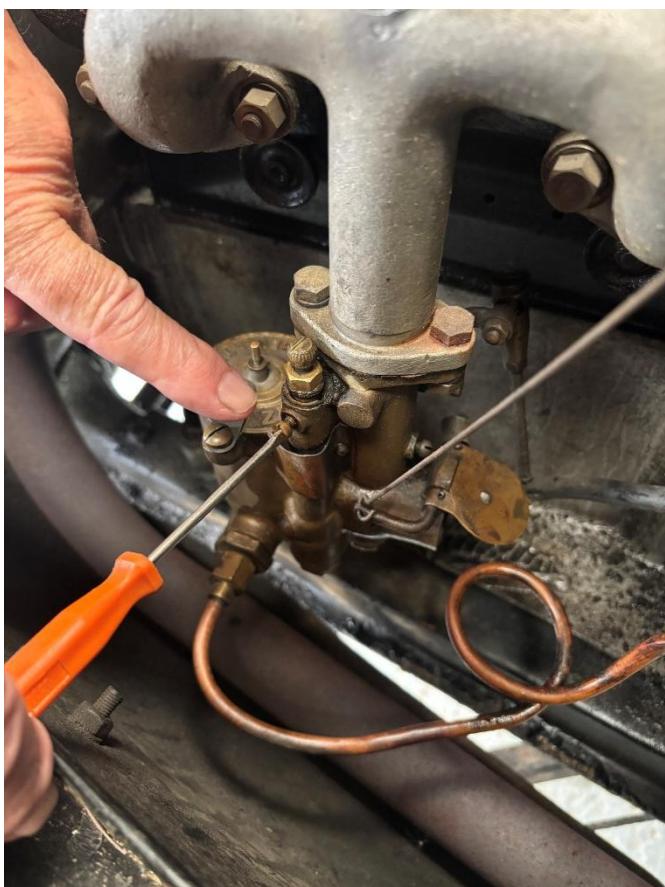
Step 2 Check Carb float is in right position

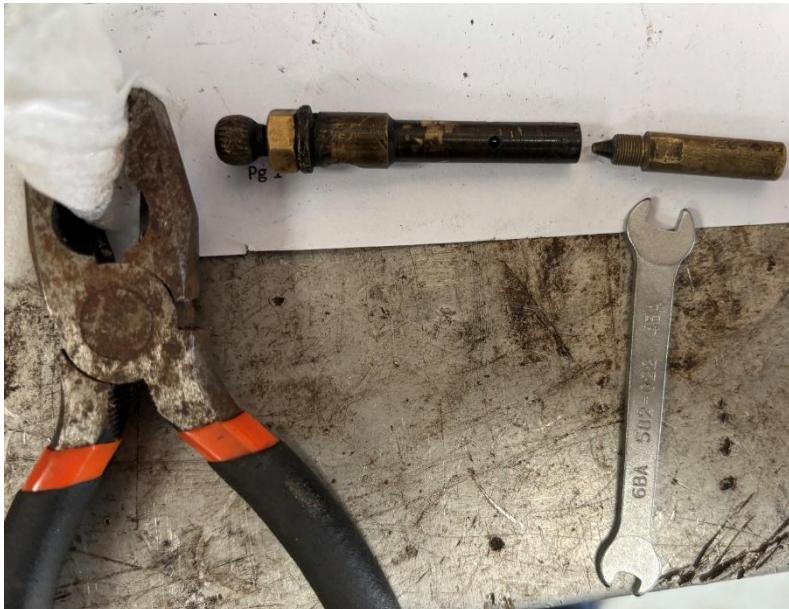
The mixture jet is accessed by taking out the slow running device. Undo the screw on its side (*left*), and then it lifts out.

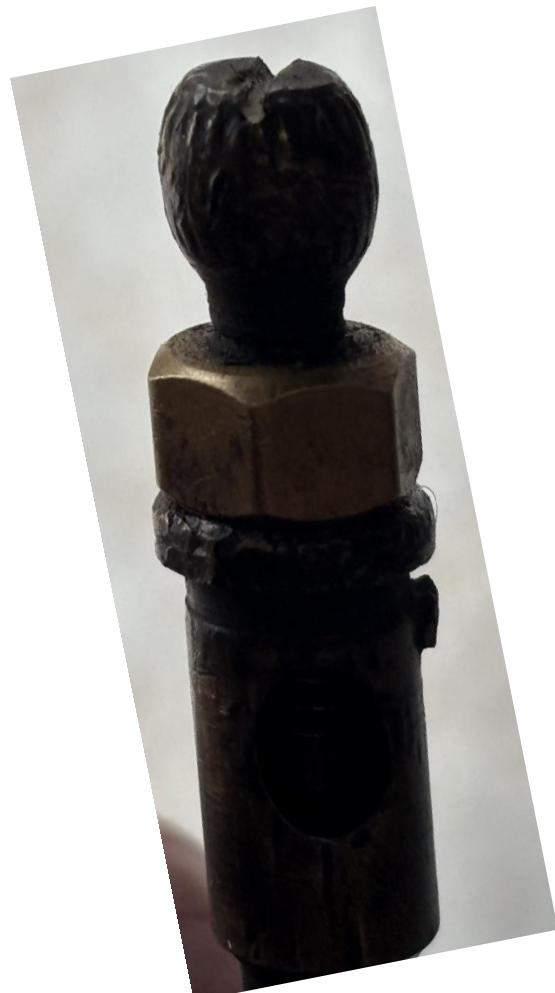
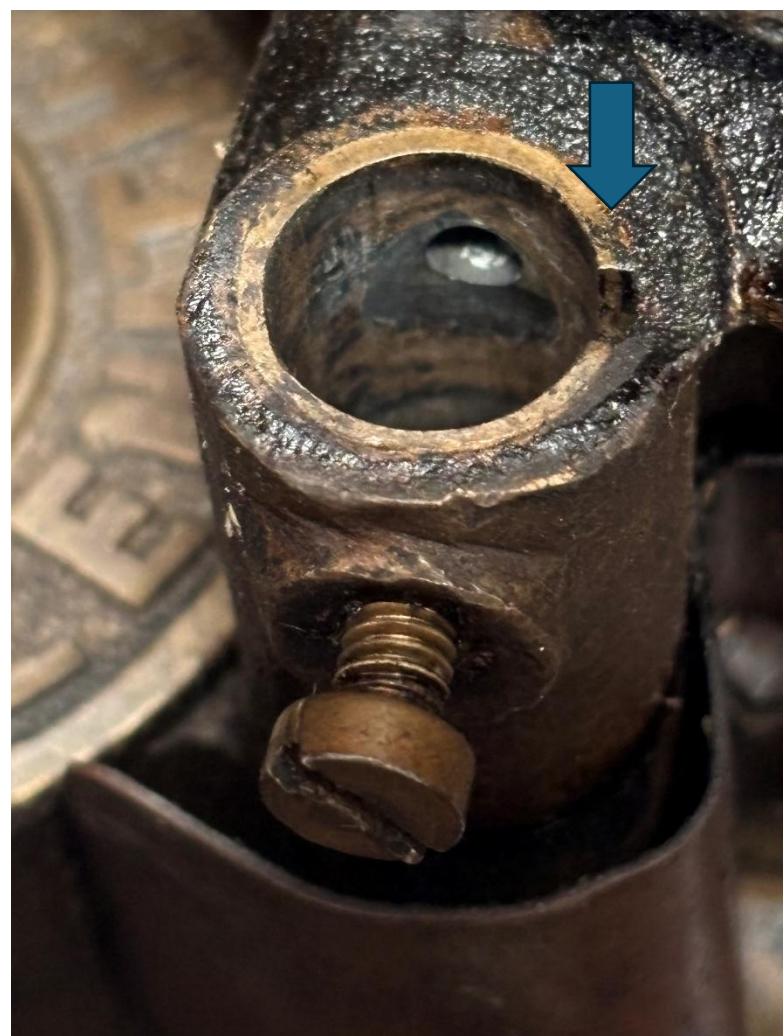
Use a 4BA spanner and pliers wrapped in padding to take the mixture jet off from its tube.

After cleaning, note that the lug at the top of the slow running device fits into a recess (arrowed) in the carb body.

The mixture screw will usually need to be adjusted after refitting.

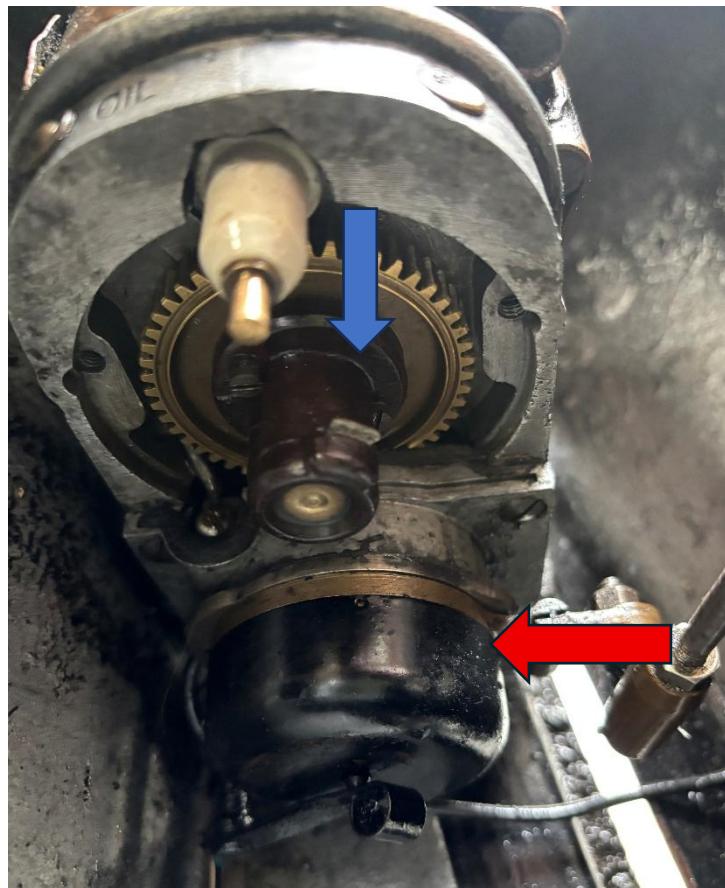
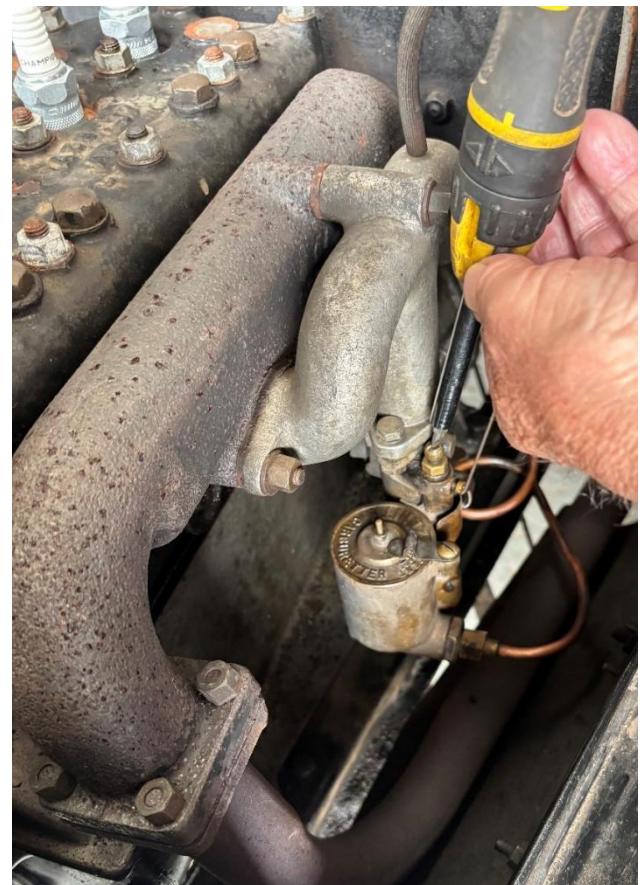
Step 5 Take distributor cap off magneto, and clean the rotor arm(blue arrow), the 4 points in the cap, and also the connection from the magneto to the cap

Red arrow is contact breaker unit

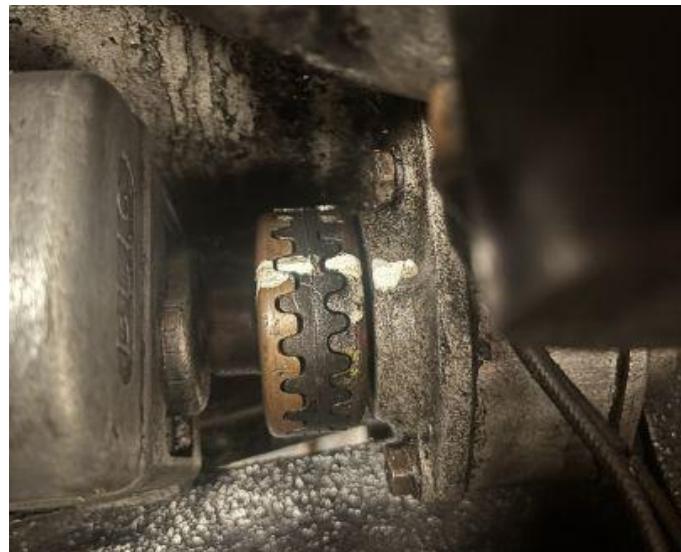
Step 7 Remove the contact breaker: on a BLIC (Birmingham Lighting and Ignition Company) Magneto, this is the lower black case at the rear, and slides off. This is necessary as the contacts are inaccessible whilst in the car. Clean the contacts with wet and dry paper, and then check the gap is about 15 thou.

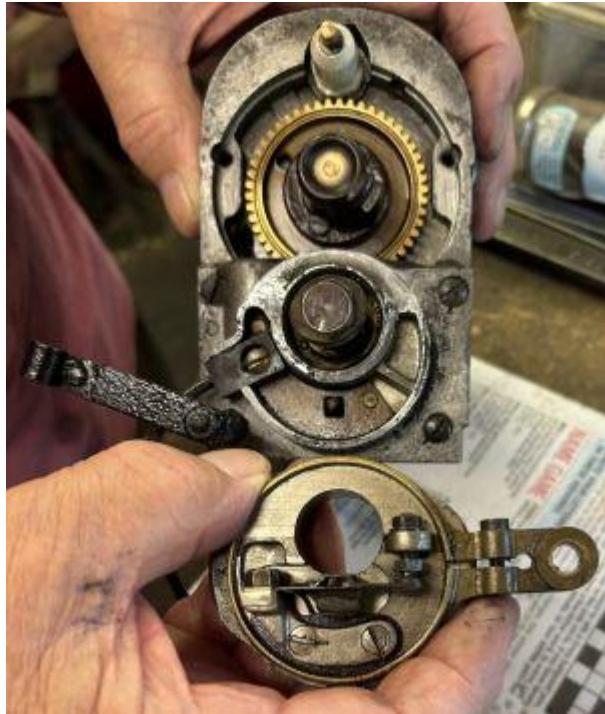
The contacts slid off the magneto. The arm on the right is attached to the ignition advance retard lever, and rotates about 45°
