## **Humble hints**

If in a weak moment you feel rash enough to lash-out on new A7 half shafts, you might usefully check two things ...

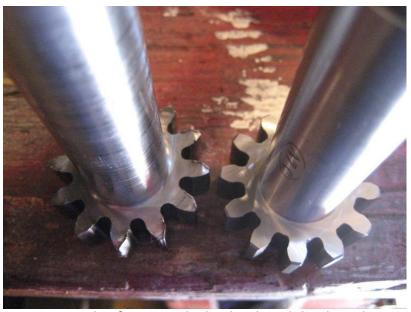
Firstly - that the pinion teeth are properly hardened. This can be checked by sneakily applying a small file to the top edges of the teeth. You should not be able to make

any impression. The photo' shows an example of one supplied unhardened that lasted less than 1,000 miles before the backlash became alarmingly obvious. The photo also shows the correct shape of teeth for comparison.

Secondly – I recommend you carefully check the length between the large end of the hub taper and the inside of the pinion. I found that when the axle nut was fully tightened, the pinion rubbed against the inner face of the differential cage. This required a small amount to be ground off the shaft side of the pinion. Very irritating!
